Monitoring Data Record

Project Title: R-2231B Myrick Pond COE Action ID: 199400590

Monitoring Year: ( 2 ) of 5

Monitoring DATA collected by: M. Green, J. Young and B. Clements Date: 7/17/08

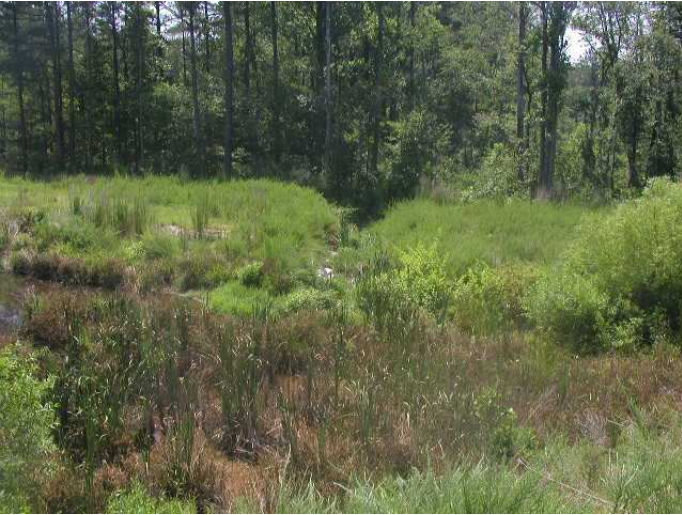
The Myrick Pond Stream Mitigation Site is stabilized for the Year 2 Summer evaluation. A bankfull event was noted during this time of monitoring. The stream was highly vegetated and stable at the time of monitoring. The cross vanes at the outlet end of the pipe are stable and functioning properly. NCDOT will continue to monitor this stream restoration site.

Photo Point #7 (Looking Downstream @ the Outlet End of the Culvert)
